# Maryland Historical Trust State Historic Sites Inventory Form

Survey No. M: 37-9

historic Glickman's Service Station

and/or common Takoma Old Town Auto Service Center

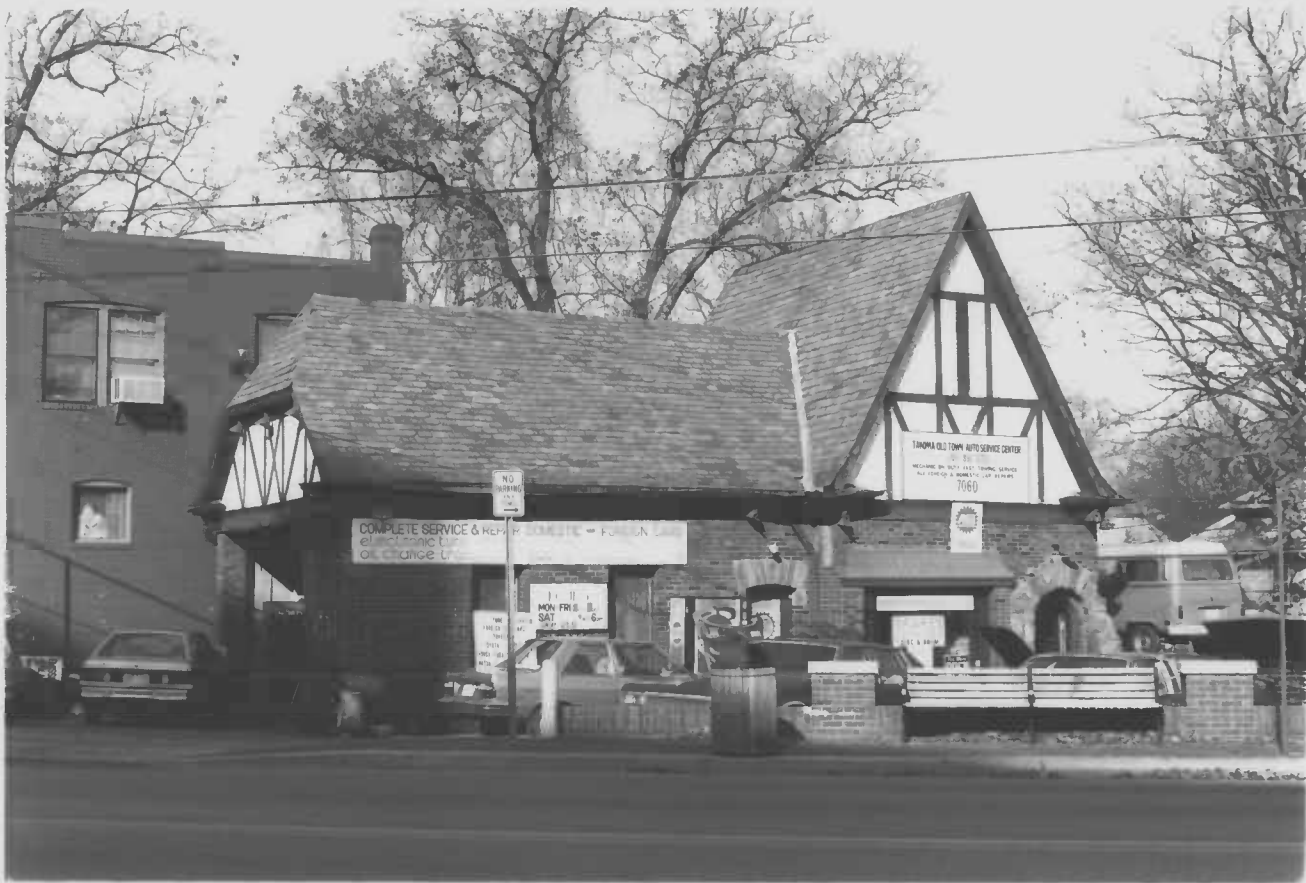
Southeast Elevation

The main elevation faces southeast onto Carroll Avenue, and consists of two windows and a door for the garage portion on the left, and a large show window and round-headed doorway to the office portion on the right. The show window consists of a single large pane of glass flanked on each side by a vertical row of several small lights. The sash is of wood. The window sits between two projecting brick piers which support a small, mansarded metal roof. The main doorway has its original round-headed, glazed, wood door set deep in a reveal. This reveal consists of a brick arch behind a massive surround of rough-cut stone of varying sized pieces, some of which form voussoirs for the arch. A tall, vertical, louvered vent in the half-timbered gable ventilates the attic over the office.
